ICANS-XIII  
13th Meeting of the International Collaboration on  
Advanced Neutron Sources  
October 11-14, 1995  
Paul Scherrer Institut, 5232 Villigen PSI, Switzerland

## EXAMINATION OF DISKS FROM THE IPNS DEPLETED URANIUM TARGET

Robert V. Strain\* and John M. Carpenter†

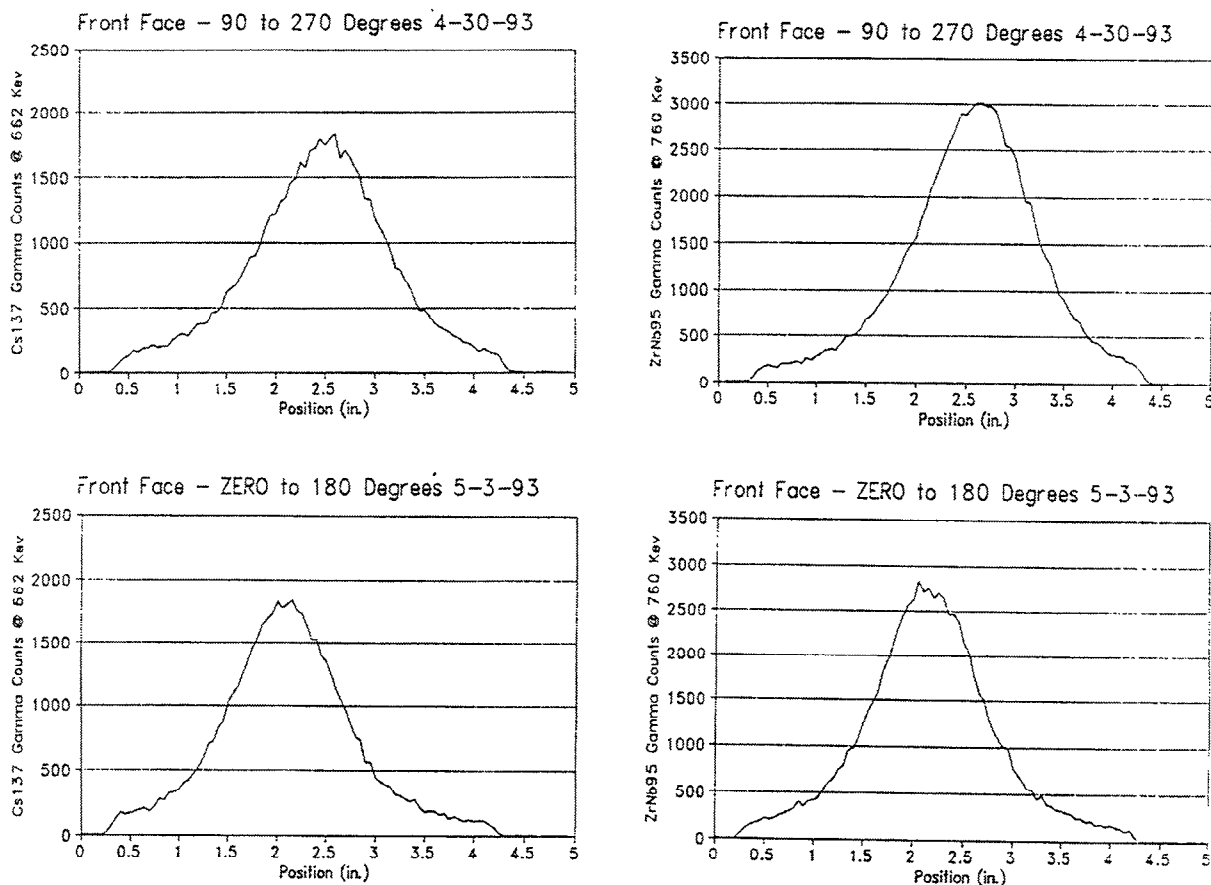
Gross beta and gamma activity measurements at the front and back face of each disk show peak values at the back face of disk #1 (120 R/hr) with slightly lower values at the front of disk #1 and both faces of disk #2 (110 R/hr). The activity diminished progressively in the remaining disks (from 105 to 4 R/hr). Diametral scans across the disks were performed at four orientations and for several nuclides. Scans for  $^{137}\text{Cs}$  and  $^{95}\text{Nb/Zr}$  fission products at the front face of disk #1 are shown in Fig. 2. The shape of these curves reflects the distribution of fission events and shows that most of the damage occurred near the center of the disks (but not perfectly centered) in a roughly circular pattern. The activity outside a radius of about 20 mm was less than half the peak activity. The area of measurable gamma activity is in general agreement with the observation of distortion of the cladding in disks #1 and #2.

Figure 2. Gamma Activity Across the Diameter of Disk #1, Typical Shapes.

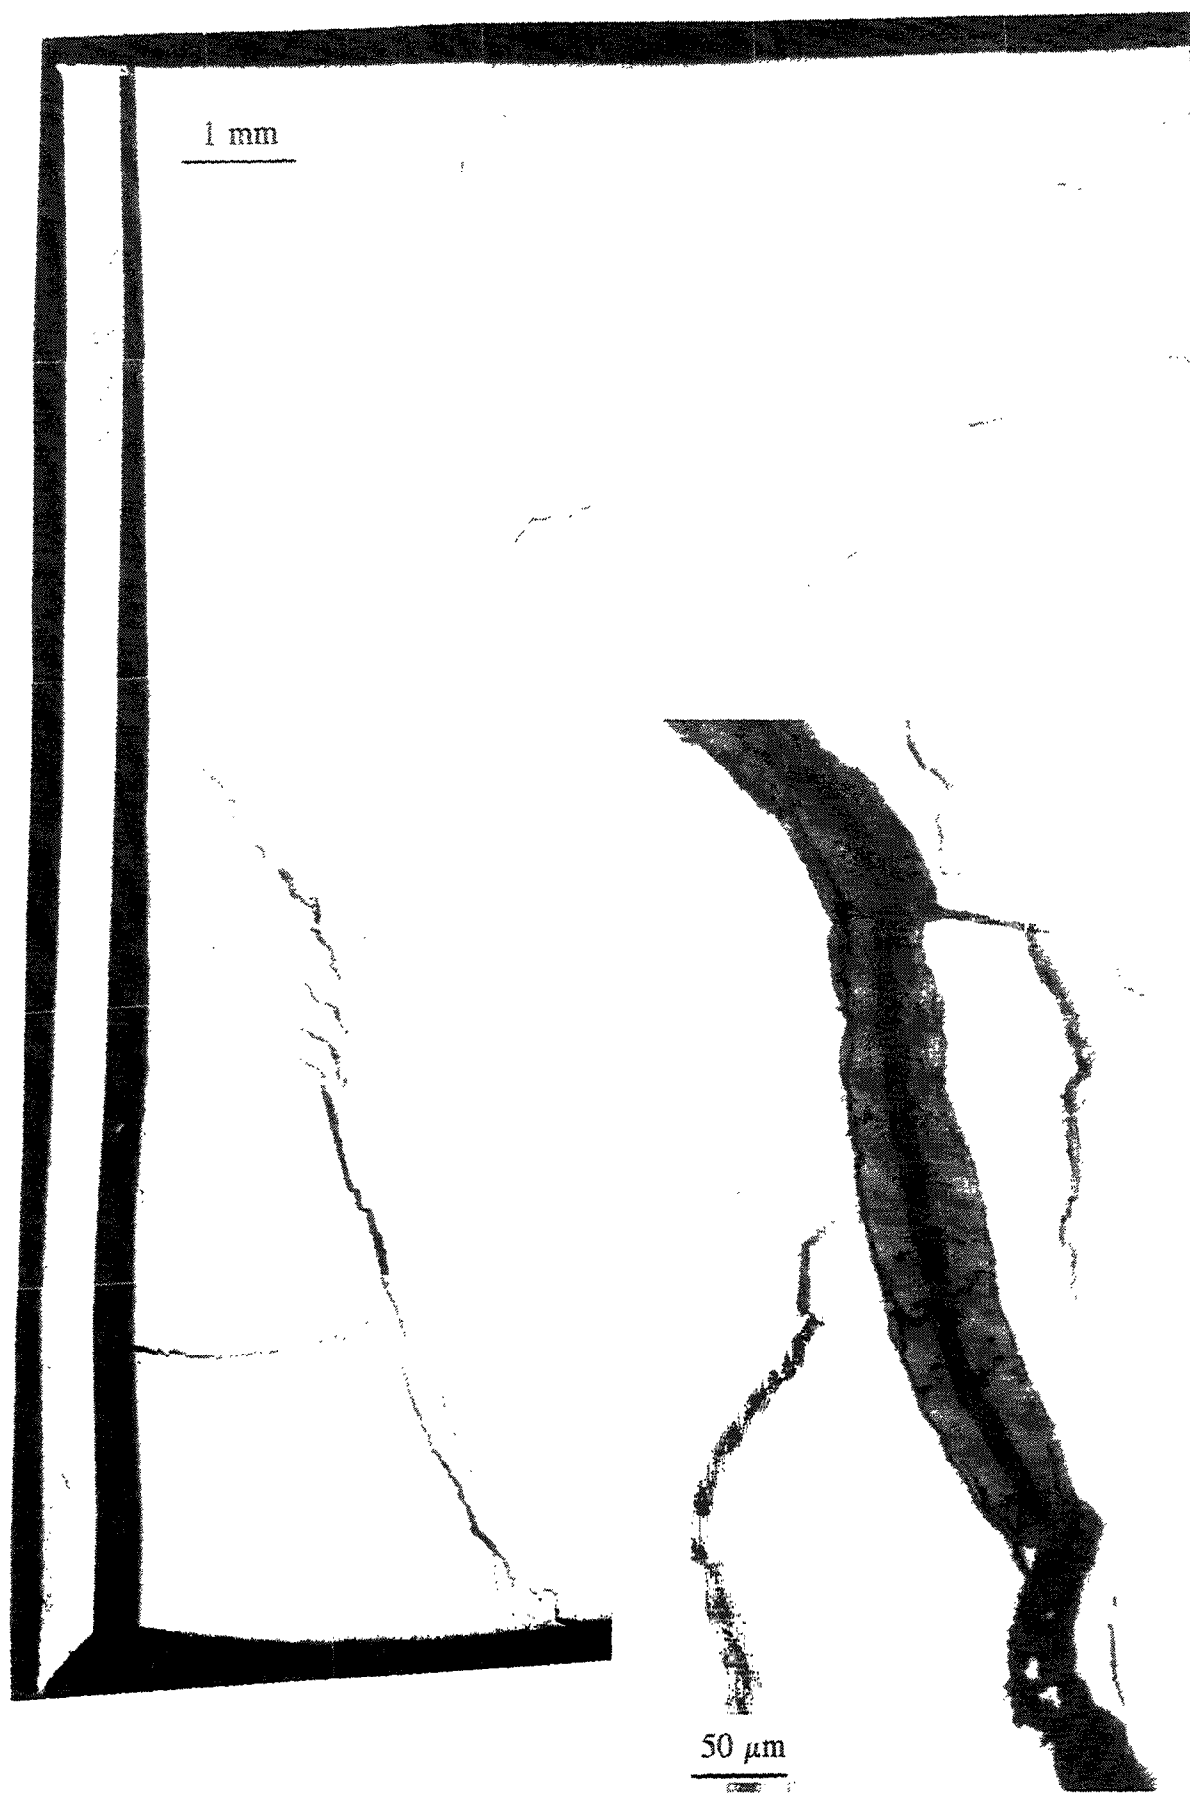
Figure 4. Micrographs of a Sample from Disk #1.

A sample for optical microscopy was cut at a location 12 to 25 mm from the center of the disk. This sample was chosen because it included several smaller cracks, but was away from the major crack filled with corrosion product. Low magnification composite photographs of the sample from disk #1 show that the cladding has separated from the core material and a network of cracks is present in the uranium. Higher magnification photographs show that every crack examined contained a gray-colored material (Fig. 4) that is assumed to be corrosion product as a result of reaction between the uranium core material and the coolant water. In most areas the corrosion product appears to be a single phase, medium gray, monolithic material that is assumed to be uranium dioxide. At the end of cracks (where the crack is extending into the core material) the corrosion product appears to consist of two phases (the medium gray phase and a lighter gray phase). The lighter gray phase may be uranium hydride (if its not an optical illusion). The formation of hydride is promoted by high hydrogen partial pressure. The crack tip would tend to trap hydrogen and is a logical location for the formation of the hydride.

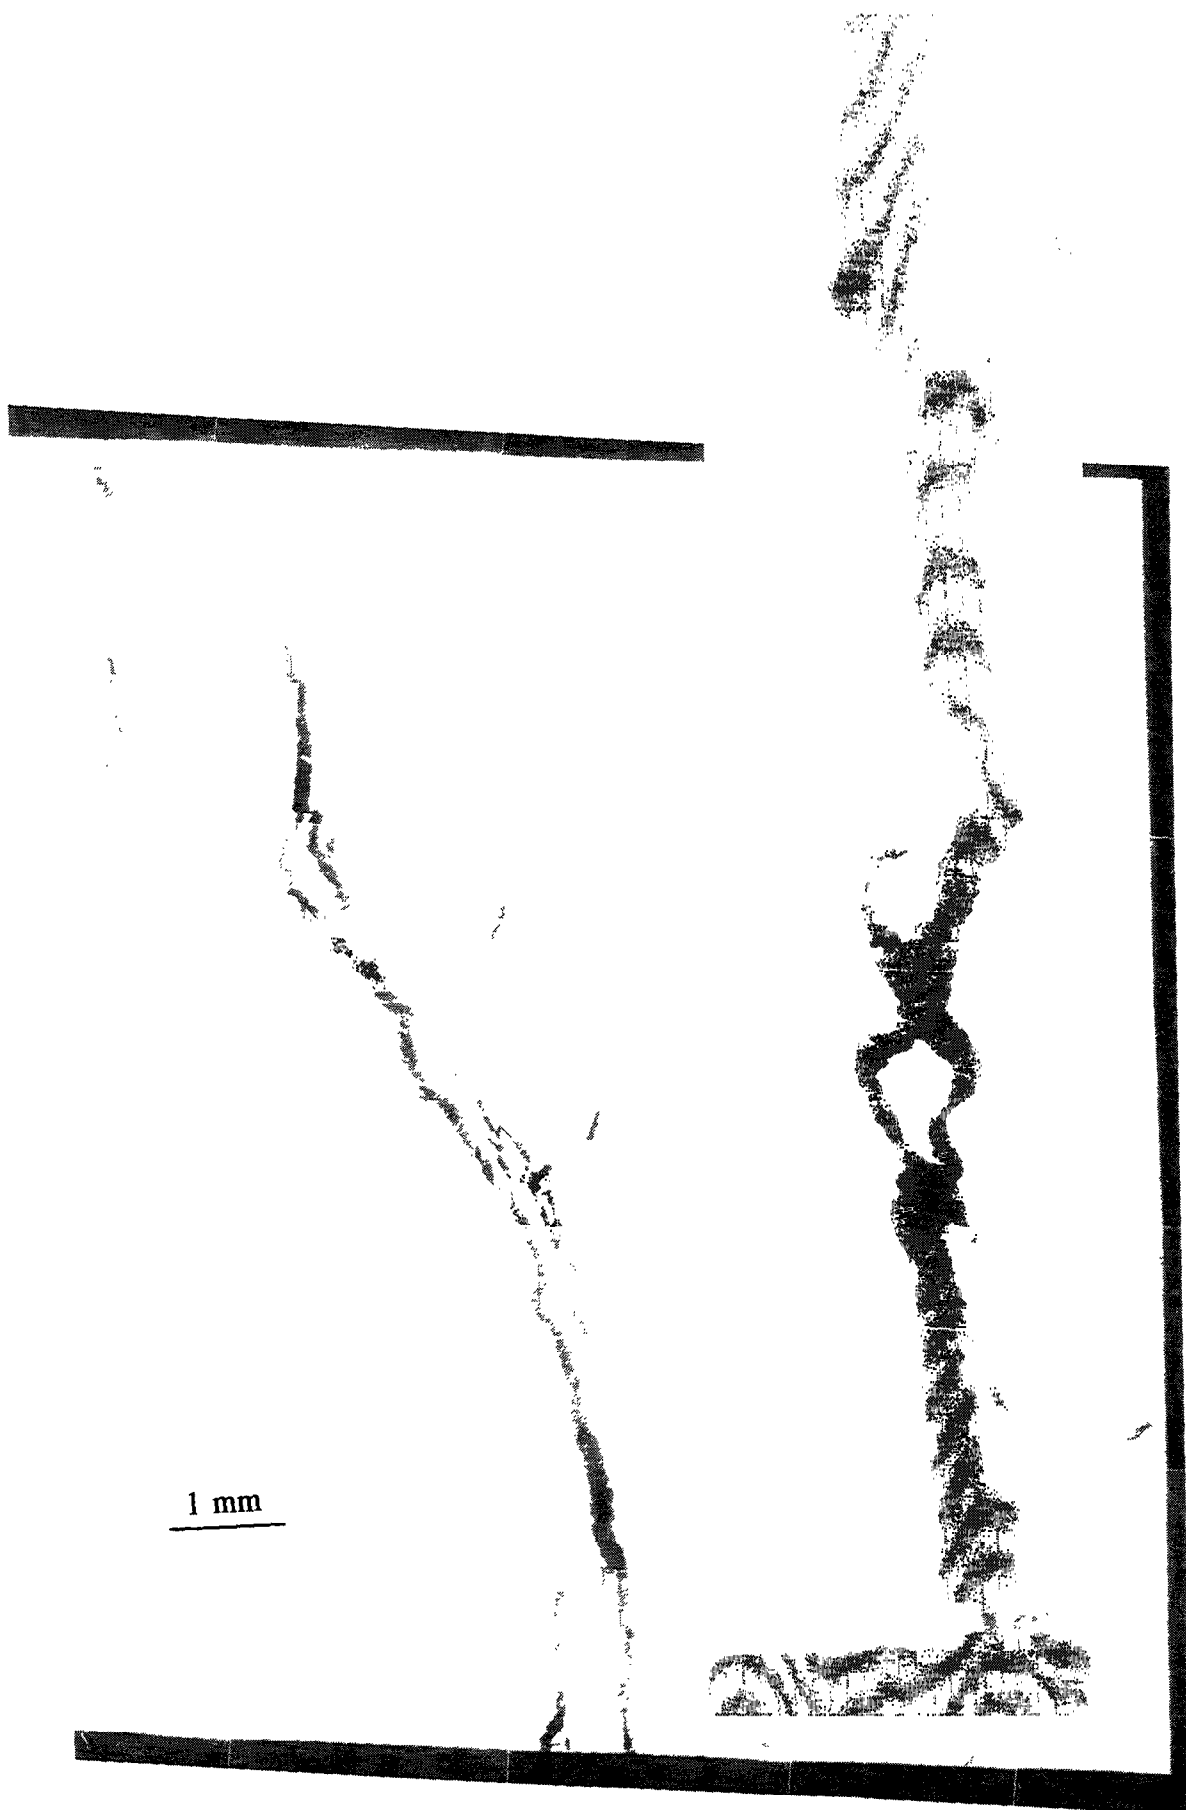
Reasoning that because corrosion had not taken place in the disk adjacent to the failed disk it must show cleaner evidence of the cause of failure than the failed disk, we performed a thorough destructive examination of disk #2. Disk #2 was initially sectioned through its center. Visual examination of the cut surfaces showed readily observable cracks in the core material at a distance of about 25 mm from the center. Two samples were cut from this area. A low magnification composite photograph of the first sample shows one large crack system in the uranium and several short cracks some distance from the main crack. Higher magnification micrographs (Inset in Fig. 5) revealed no evidence of corrosion products or other material in these cracks (the material that appears in the micrographs is epoxy that was used to fix the sample in a mount). The cracks in the uranium indicate that the failure of the cladding on the first disk initiated in the uranium. We conclude that the cracks in the uranium were the result of anisotropic swelling from a combination of thermal cycling and irradiation.

Figure 5. Cracks in the Core Material of Disk #2

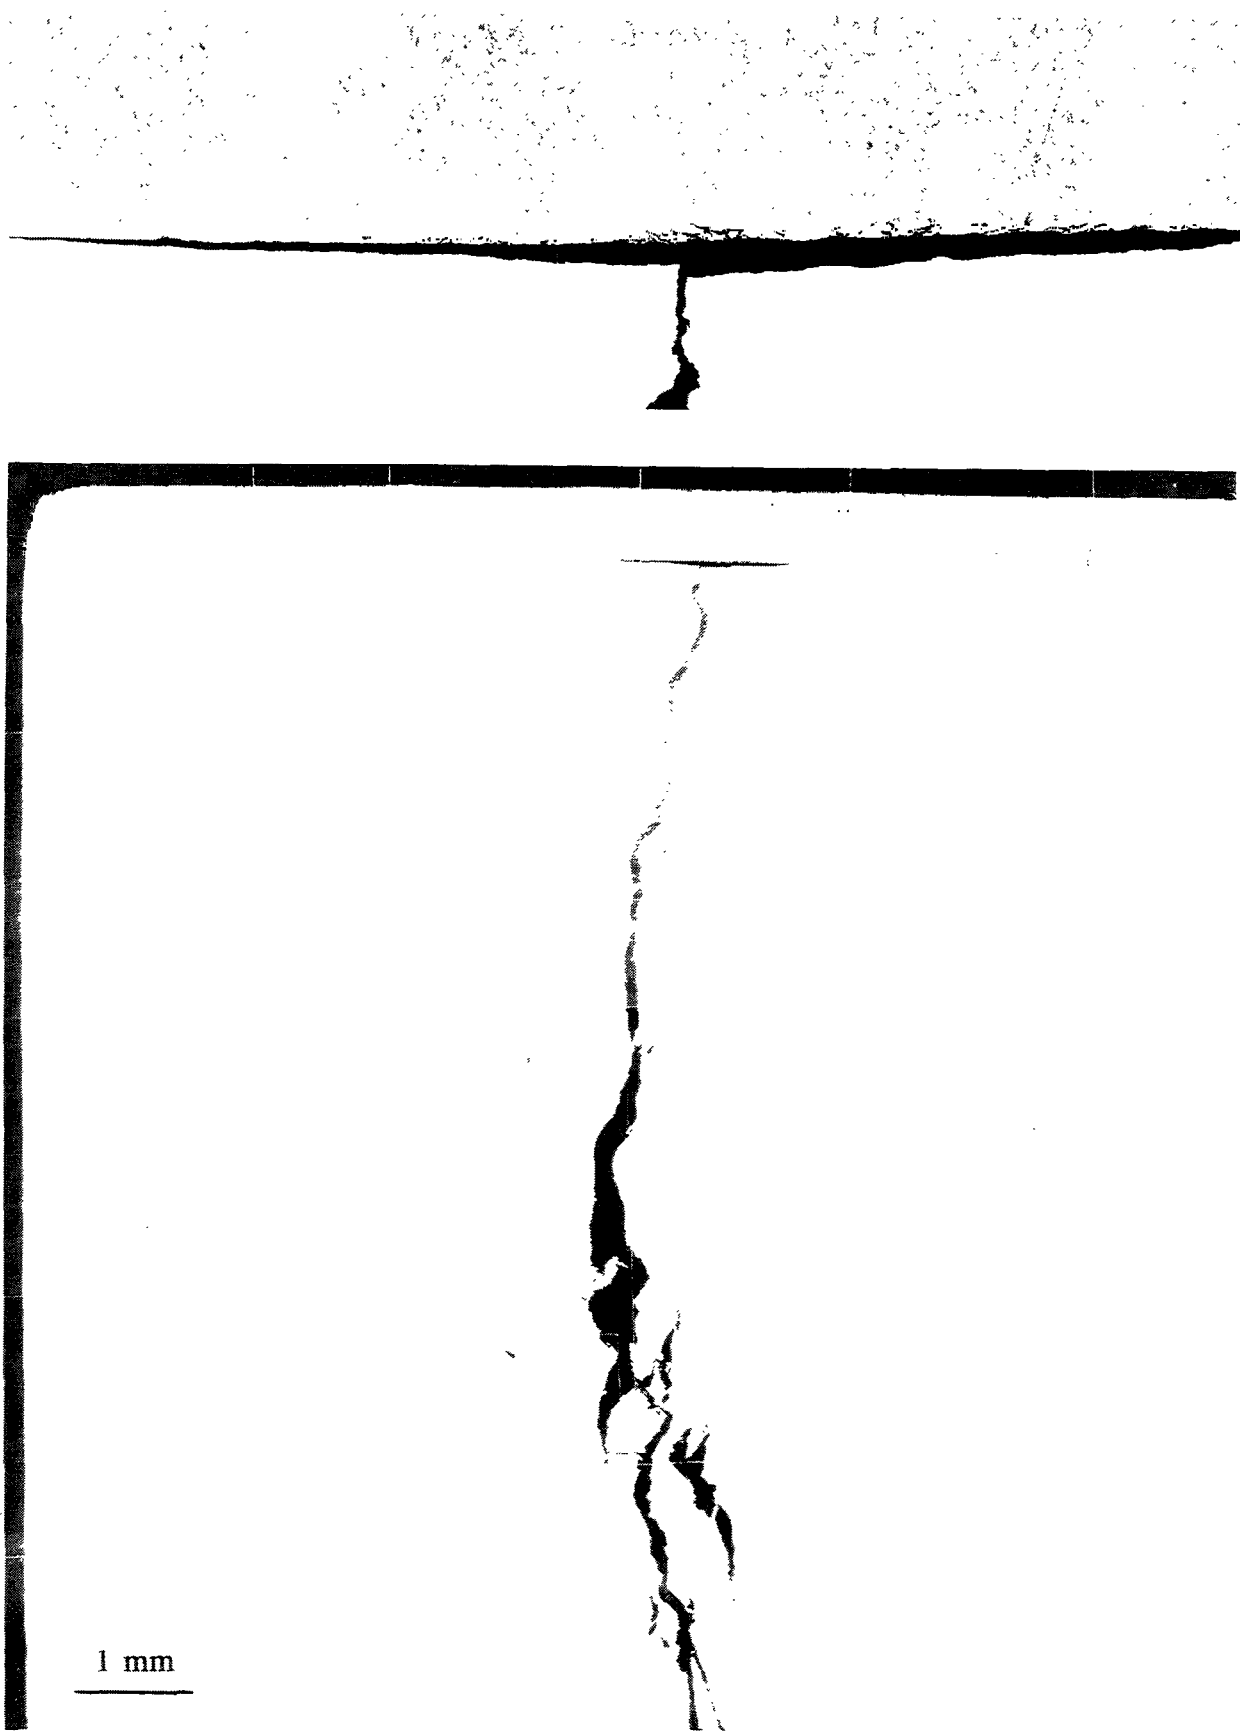
A second sample was cut that included the back face of disk #2. A low magnification composite micrograph, Fig. 6, of this sample shows that the main crack system extended through the entire thickness of Disk #2 to the back face. Again the cracks contained no corrosion product. At the intersection of the main crack with the cladding on the rear face of Disk #2, the core material appears to have pulled away from the cladding. The uranium on the two sides of the crack appear to be displaced from each other parallel to the direction of the crack. There appears to be a second phase present at the inner surface of the cladding in the region where the core material has separated from the cladding. Etching of the cladding indicates that the microstructure of the cladding is altered (the addition of fine precipitates) to a depth of about  $150 \mu\text{m}$  in the region of the separation.

Figure 6. Intersection of a Crack in the Core Material with the Cladding, Disk #2.

These results are sufficient to indicate that the use of an alloy that stabilizes the uranium in the cubic (isotropic) gamma phase should greatly lengthen the useful life of the source. The examination also indicates that a second phase at the core-cladding interface may have played a secondary role in the failure of the cladding. Therefore, steps should be taken to avoid conditions that could result in the formation of intermetallic or other brittle phases at this interface.
