Recent status of a cold neutron disk chopper spectrometer, AMATERAS

Abstract. Recent issues of a cold-neutron disk-chopper spectrometer AMATERAS are reported. Five years have been passed since we had the first neutron beam on AMATERAS. The user program is running steadily since after the visiting of the first user in 2009. In parallel to that, machine studies and commissioning works to improve spectrometer performance have been continuously done. Effort has been done on fixing the beam-transport problem, which causes the serious intensity loss at the sample position. After replacing 8.6 m section of super mirror and re-doing the mirror alignment, a part of intensity has been recovered, while still some of problems are remained. We also spent effort on reducing background caused by several sources. Study on the background sources and implementation of countermeasures are in progress.

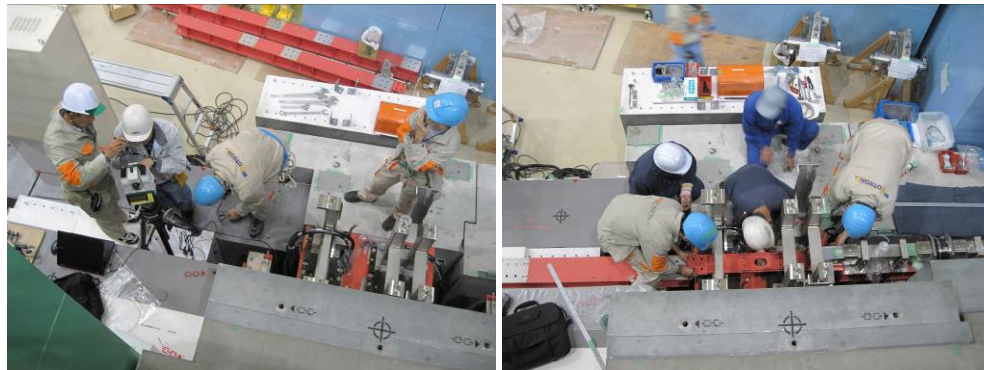
Figure 6. Re-alignment work at AMATERAS.

and new bellows was done in November 2013 (Fig. 6, 7). After the refurbishment, positions of vacuum jackets were measuring by using a laser tracker and were recorded.

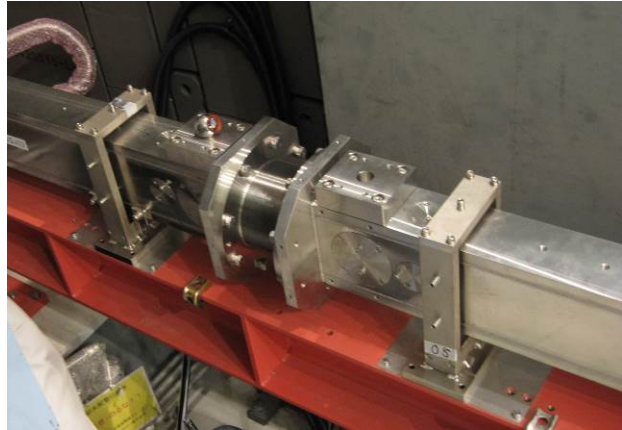
Figure 7. A photo of the same part shown in Fig. 5 taken from the opposite side after the refurbishment. One can see that designs of support frames and a bellows have been changed.

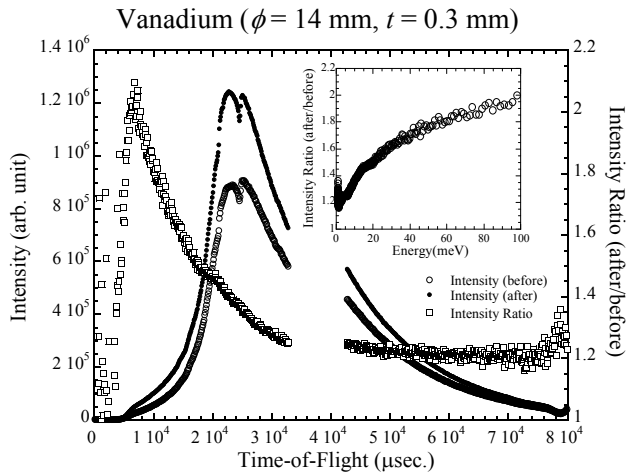
Figure 8. Scattering intensity from vanadium cylinder ($\phi = 14$ mm, $t = 0.3$ mm) before/after the refurbishment of the beam transport. Intensity ratios are also shown.

After the large refurbishment, in February 2014, we checked the neutron flux at the sample position by measuring incoherent scattering from vanadium and by measuring inelastic and quasielastic scatterings from several samples, which were measured on AMATERAS before. We observed substantial increase of the intensity. At long wavelength region, intensity after refurbishment was 20% higher than that of before and, at higher energy region, it became almost twice (Fig. 8). The absolute intensity at the sample position, however, is still lower than the MC simulation results, which may imply that we should more seriously consider the 3rd possibility, i.e. the validity of our MC simulation calculations done before the construction. Another remaining problem is that we found the drop of the intensity very recently. We are afraid that jackets or mirrors in them may be moving. We are watching the intensity change of AMATERAS carefully and are planning to open the beam line shielding in the next shut down to check the alignment.

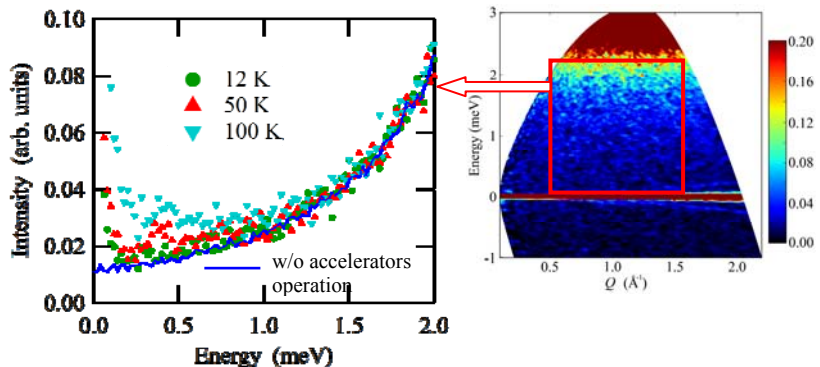
Figure 9. Energy dependences of Q -integrated ($0.5 < Q < 1.5 \text{ \AA}^{-1}$) intensities from magnetic powder sample. Results at three different temperatures are shown together with the data measured when J-PARC accelerators were stopped (solid line).

background level (except that from samples) in the experiments on AMATERAS is $30 \text{ Count h}^{-1} \text{ PSD}^{-1} \text{ m}^{-1}$, which is time independent. One of examples is shown in Fig. 9. We are also suffered from another type background. It happens within short time range and simultaneously illuminates all pixels of detectors. As results, flat and Q -independent false inelastic signals are observed (Fig. 10).

One can see in Fig. 9 that the time-independent background counts at AMATERAS do not depend on whether the accelerators are in operation or not. The evidence implies origins of these counts are suspected to be electric noise of DAQ system and/or from environment radiations. By increasing the lower-level discrimination (LLD) (Fig. 11) or decreasing applying high-voltage (HV), we confirmed that the time-independent background. However, we are cautious about changing DAQ parameters, since changing the LLD higher than the optimized level causes decrease of the counter efficiency and decreasing HV causes decrease of the counting rate. About the environmental radiation background, most of parts come from the floor under the scattering chamber (Fig. 11(b)). As a series of tests, we put polytrimethylene and boracic acid bags under the scattering chamber. We found boron contain material is effective to reduce the background. Therefore, now we are preparing B_4C tiles to cover the floor of under the scattering chamber.

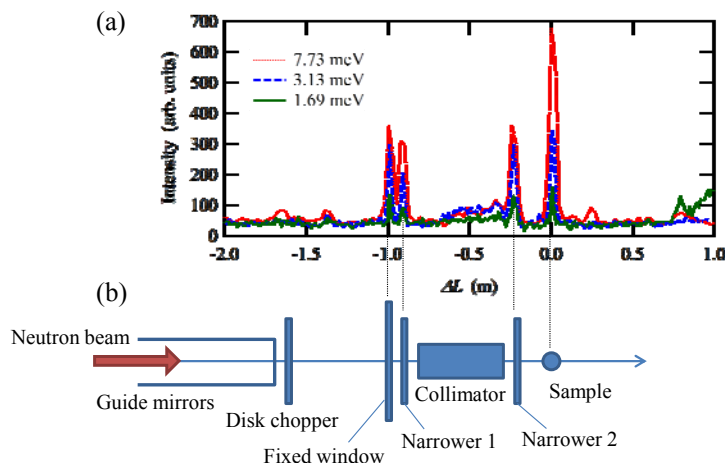
Figure 12. Time-of-flights of false signals are converted into the flight distances ($\Delta L = (\text{flight path length from the source}) - 30 \text{ m}$)

About short-time background, by analysing time-of-flight and flight path length we spotted the source of false signals. We converted the observed times of false signals into the flight path lengths from the source. These positions correspond to the position of a Cd window, B_4C beam narrowers and the sample position. We suspect that neutrons arrived at these positions emit γ -ray, which travels speed of light and causes noise to ^3He counters. There are so many Cd plates and B_4C near and around AMATERAS beam line. We are planning to replace those which possibly have direct neutron beam with other materials, for example, ^6Li .
